SERVICE BULLETIN: JSB 013-1

Date: 8th August 2006

Subject: Jabiru 2200 Engine Rocker Chamber Vent

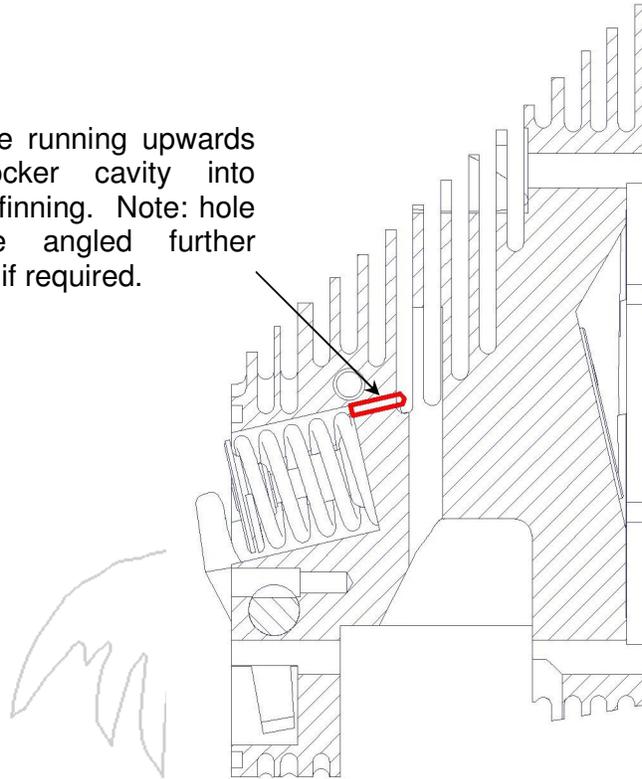
Figure 2. Sectioned View of Head Assembly – Hole Shown.

Vent hole running upwards from rocker cavity into external finning. Note: hole may be angled further upwards if required.

- i) With reference to the engine's Instruction & Maintenance Manual, remove the aircraft cowls and engine ram-air ducts.
- ii) Remove the rocker covers from the engine.
- iii) Locate the position shown in Figure 2 below and use a small centre punch to mark the hole position.
- iv) Using a 3/32" drill bit, drill a hole in the head as shown. The hole must angle upwards to encourage oil to flow back into the rocker cavity instead of out into the engine bay. Before drilling, coat the tip of the drill bit with grease to catch the aluminium shavings from the hole. Drill in stages, cleaning and re-greasing the drill every second or two. Ensure that no loose shavings escape into the rocker cavity.
- v) Replace the rocker covers re-assemble the aircraft.
