Jabiru Service Letter: Valve Spring Washer Wear			JABIRU AIRCRAFT PTY LTD P.O. Box 5792 Bundaberg West Queensland, Australia. Phone:+61 7 4155 1778 Fax:+61 7 4155 2669 Email: info@jabiru.net.au		
JSL 008-2	Release Date: 19th December 2017	Effective Date: 19th December 2017	Affected Models: See Sheet 1	S/No. Range: See Sheet 1	Page 1 of 5

SERVICE LETTER: JSL 008-2

Subject: Valve Spring Washer Adverse Wear

Affected Engines: All Jabiru Engines up to Serial No. 22A3713, 22B317 & 33A2603 unless fitted with hardened valve spring washers during servicing.

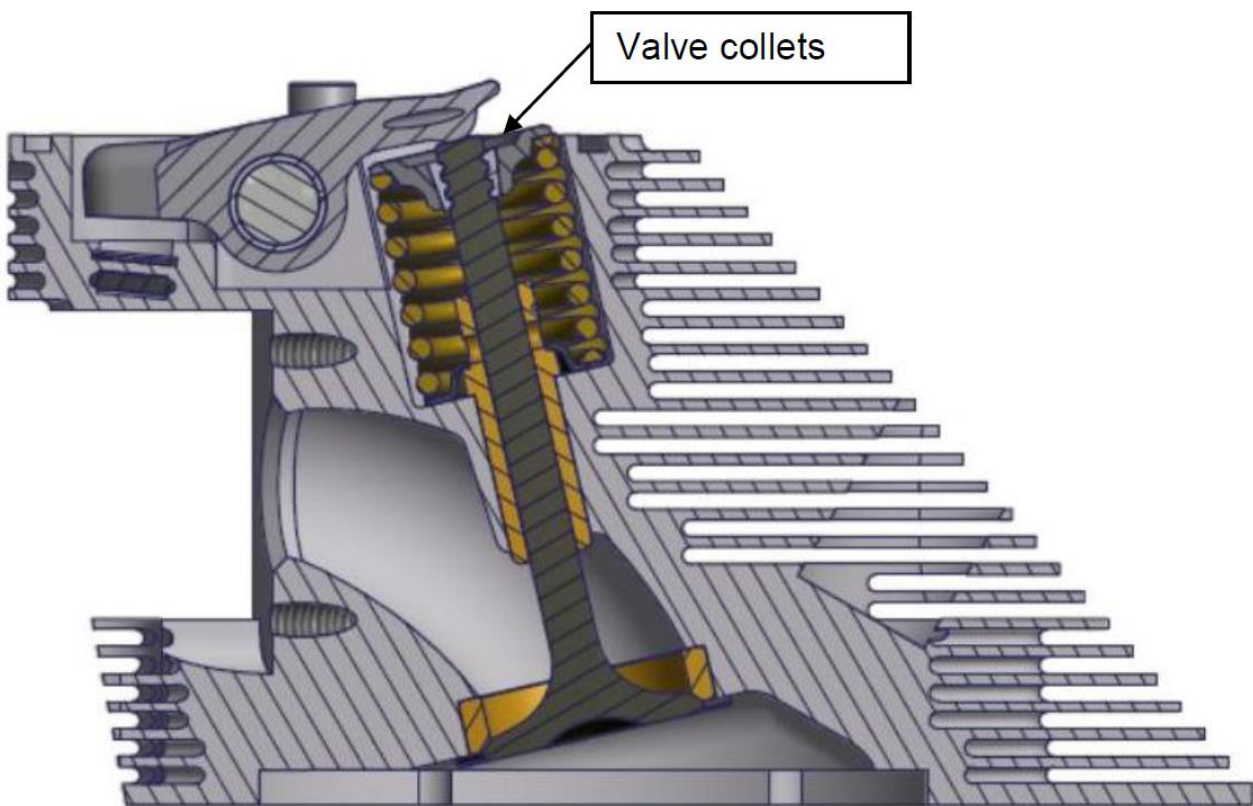
Figure 1: Valve & Spring Cross Section

- Jabiru Engines use a conventional arrangement of washers and collets to retain the valve spring assemblies (Figure 1).
- By design the valves are normally free to rotate within the valve collets. The valve actuation mechanism applies a small rotational force to the valve, rotating it to maintain valve sealing.
- Two incidents, one year apart, have been reported to Jabiru Aircraft: in each a valve jammed in the collet, causing the top spring washer to rotate with the valve and wear against the valve spring, eventually causing a failure of the washer and engine stoppage.
- In both cases the parts in question had completed 600 – 800 hours in service.
- In both cases the engines were operated in dusty conditions and dirt contamination was found within the carburettor and intake plenum. It is likely that dirt contamination caused the valve to jam in its collets.

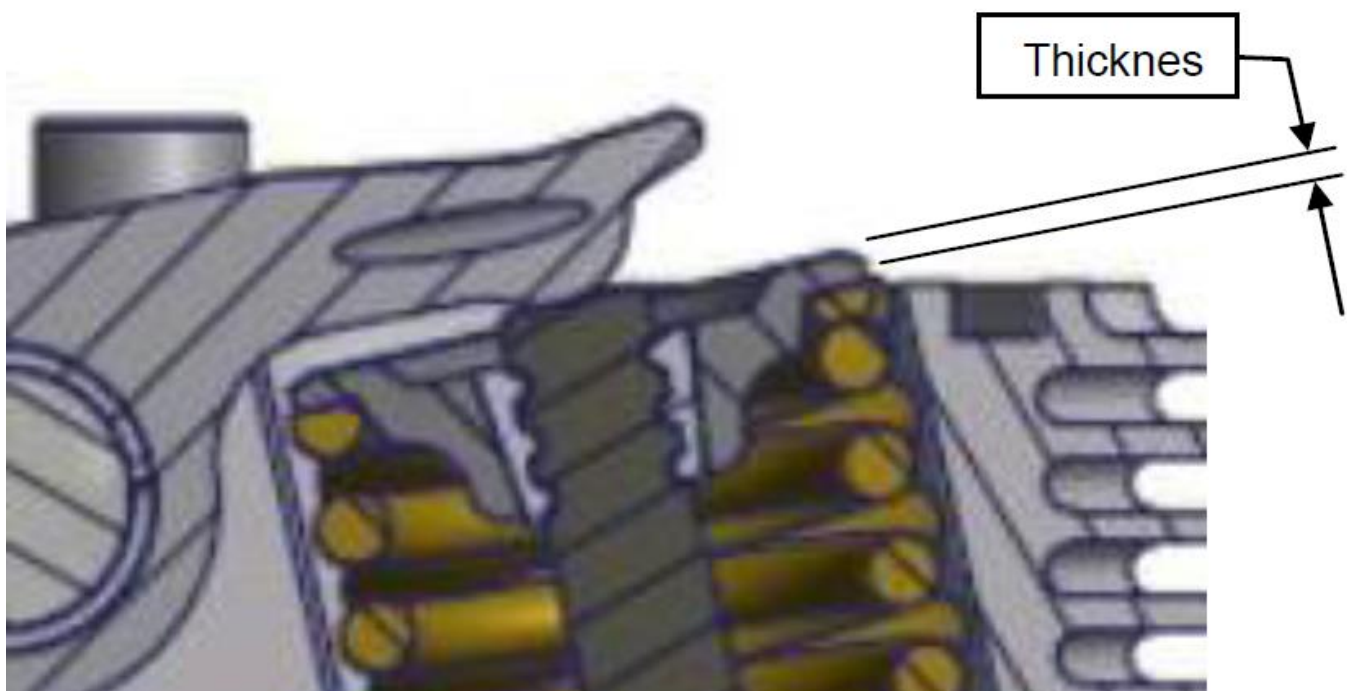
Figure 4: Washer Thickness Measurement

- Visually inspect the top spring washer. A washer which is being worn may show burrs on the outer edge and the reduced thickness may be evident.
- The thickness of the top valve spring washer may be measured (Figure 4). Older washers should measure 1.5mm, newer parts 2.0mm (2mm thickness was introduced from S/No. 332486, 22A3514 and 22B263 and spare parts from June 2011). Any measurement below 1.3mm must be investigated; failure typically occurs at around 1.0mm.
- Thickness of washer can be measured, without head disassembly, by using a depth vernier. See JSL014 Cylinder Head Inspections for additional information.
